# Lessons Learned

## *Fall from Fixed Ladder with Grab Bars Results in Injury and Fine*

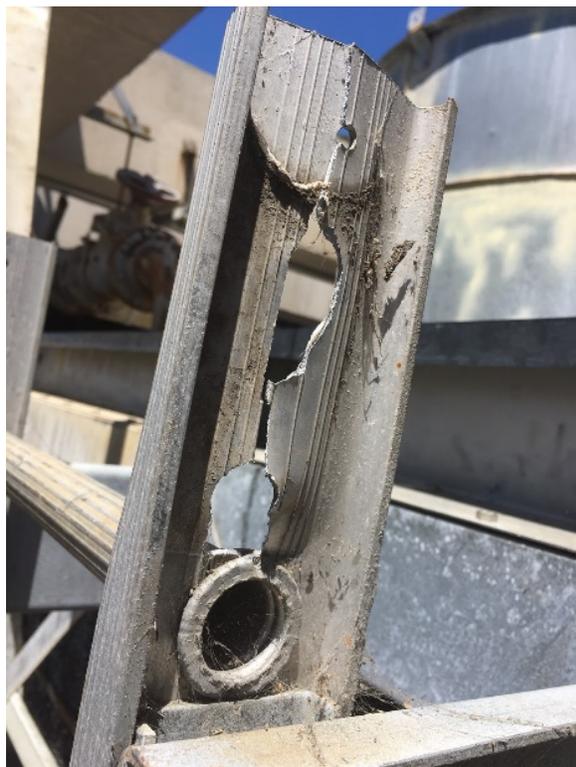
*Photo 1 - The Sheared Metal Ladder*

It is strongly believed that metal fatigue and galvanic (bimetallic) corrosion weakened the aluminum ladder and contributed to the side rail failure at the connection to the grab bars—2 bolts with nuts and washers. The metal fatigue may have been caused by repeated low frequency compression and tension loading in the area near the bolted connection points. The combination of these effects—metal fatigue, corrosion, and intermittent load forces—during a span of 30 years, is the suspected failure cause.

- The ladder system should have been built to withstand greater load forces.

- The connection hardware should have included a solid insert and backing plates on both sides to distribute load forces over a wider area.
- The connection method should have been designed to minimize galvanic (bimetallic) corrosion between differing metals.
- The ladder, grab bars and connection hardware should have been treated with a sealer protectant or paint to slow the effects of corrosion.
- The ladder system should have been inspected at least twice a year and documented.
- Corroded, excessively rusty, or suspect parts should have been replaced.

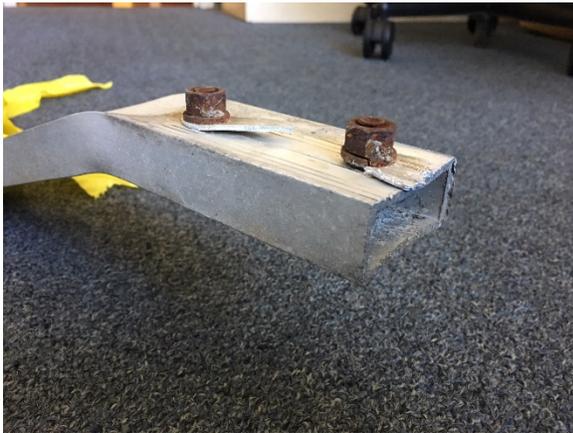
*Photo 2 - Grab Bar at the Connection Point*

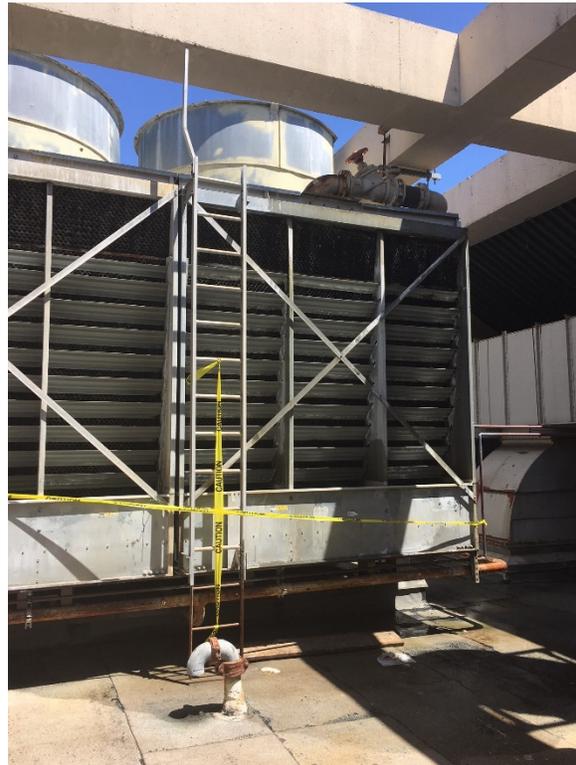
*Photo 3 - Broken Ladder*
