Lessons Learned

Eye Exposure to Specular Reflection

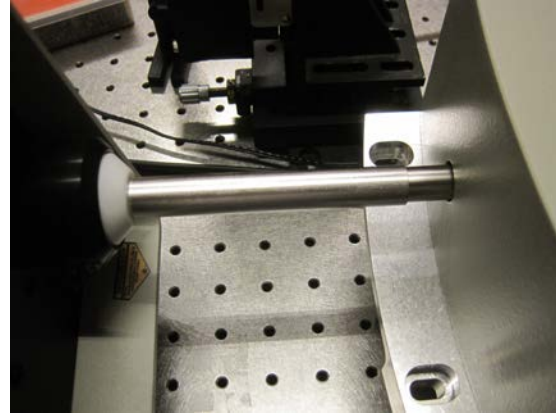
Photo 1 – Beam tube in place between DPSS laser (pump laser) and Ti-Sapphire oscillator (normal position).

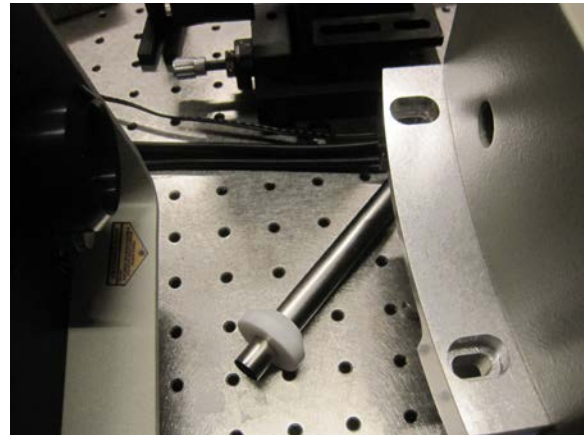
The cause of the exposure was the specular reflection of the laser beam off the beam tube when it dropped.

Photo 2 – Beam tube in dropped position

The researchers will replace the two piece beam tube with one that is anodized black and spring loaded. They will verify that it secured/anchored to the pump laser and oscillator. Laser users are to perform and document safety inspections of the laser system prior to each use and verify that engineering control items (beam stops, curbs, barriers, tubes) are in place and secured from movement before turning on the beam.
