LESSON LEARNED

Laser Eye Exposure from a Specular Reflection

Berkeley Environment, Health & Safety

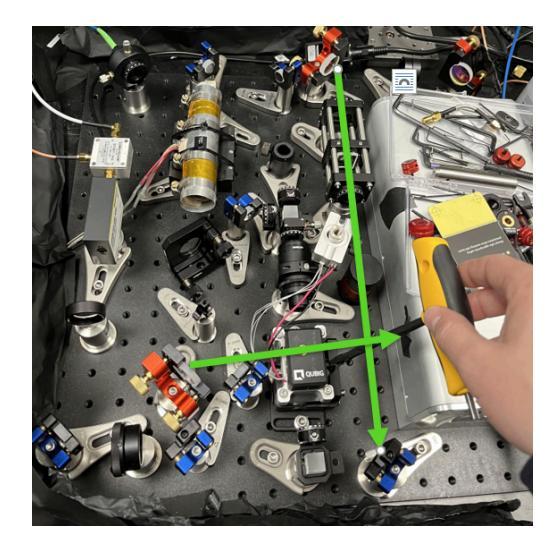
A researcher walking towards an optical table was exposed to a laser beam that reflected off a hex ball driver tool. Another researcher at a nearby bench was installing an optical component on a breadboard when the hex ball driver he was using inadvertently moved into an active beam path. The hex ball tool had a reflective surface.

Tool in beam path

The direct cause of the incident was the insertion of a ball driver tool with a reflective surface into the path of the 0.02 W continuous wave beam (420 nm), which reflected the laser beam into the eye of a nearby researcher.

- Research group will replace tools that have reflective surfaces/coating with tools that have matte black finish.
- Research group will draft a separate procedure for all "new" optical builds. This procedure will include safety requirements.
- Research group will review and revise all laser SOPs incorporating new procedures for working in the lab. This will include photos of how alignment mode can be turned on for each optical system. Group will submit revised SOPs to the EH&S Laser Safety program for review.
- Research group will have a procedure to ensure that all laser users have met the campus laser safety initial training requirement prior to working on any optical experimental set-up and are provided appropriate "hands-on" training.

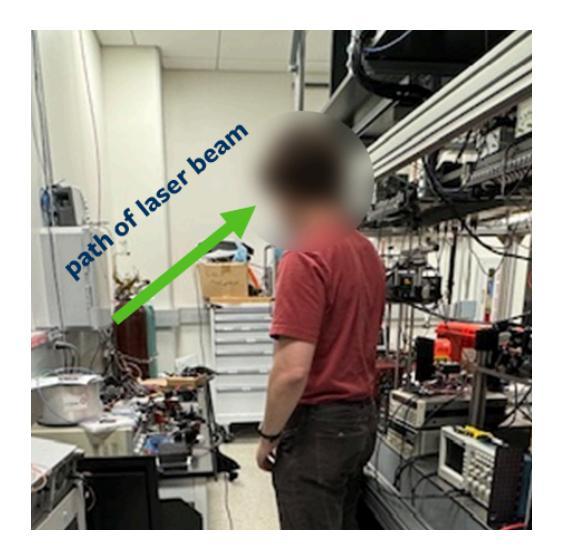
Approx. location of researcher struck by specular reflection

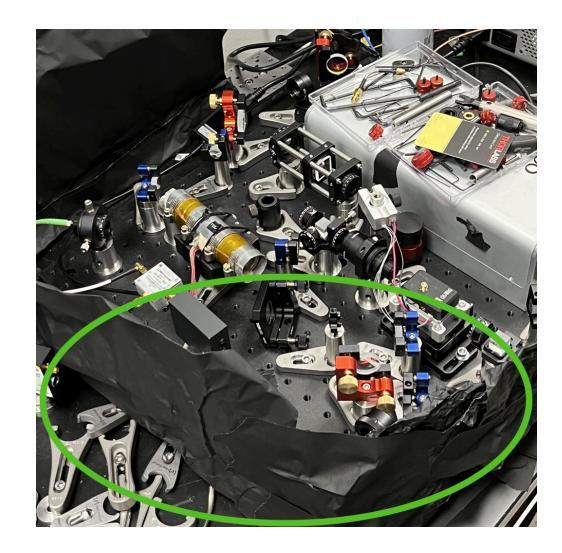
Low beam curb/barrier

- Install appropriate beam barrier/curb to contain any specular or diffuse reflections. Ensure that beam barrier/curb height is sufficient to contain any entrant reflections. Beam curb/barrier was too short.
- Laser SOPs shall be reviewed for operational accuracy and include detailed procedures on conditions when laser eye protection is required to be worn.
- Develop a procedure to ensure that all laser users have met the campus laser safety initial training requirement prior to working on any optical experimental set-up and are provided appropriate "hands-on" training.
- Wear appropriate laser protective eyewear whenever working with an open laser beam.

- Laser user should have used tools that do not have a reflective surface or coating.
- Laser user and the other researcher in the same room should have worn appropriate laser protective eyewear as required.
- Laser user should have installed appropriate laser beam curbs or barriers (including those of appropriate height) to contain or block any stray laser reflections.
