Lessons Learned

Plastic Secondary Container Shatters Due to Dry Ice Sublimation

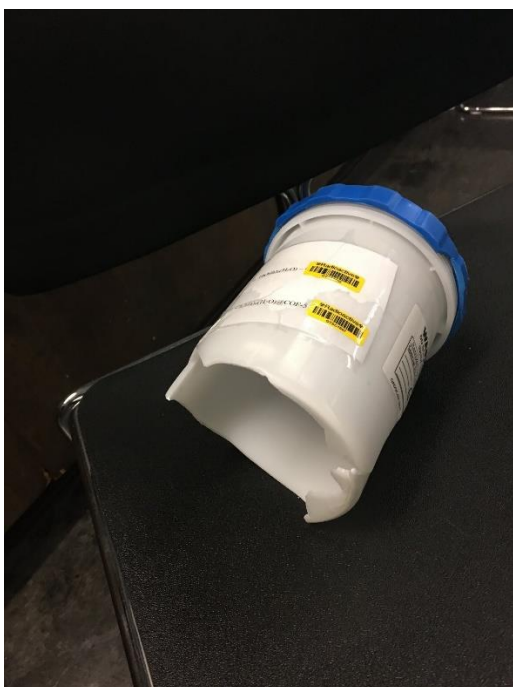
The researcher recruited the help of a staff member to unscrew the secondary container. With each individual holding one end of the container, the two tried to screw it open. In the process, the secondary container blew apart with a very loud popping sound, shattering both secondary container and glass vial. All contents impelled outwards. Glass shards impinged on the staff member's face and on his regular prescription glasses. Both researcher and staff member reported hearing short term ringing in their ears as a result of the shattering.

Photo 1 – Shattered Secondary Plastic Container

Dry ice sublimates under normal temperature and pressure conditions. In this case, sublimation of dry ice led to gas buildup and overpressurization of the secondary container. In addition, the low temperature of dry ice likely condensed water vapor within the threads of the screw cap, causing the plastic material to weaken and fuse together. The container shattered due to the buildup of gases within a weakened plastic material.

- An insulated material with a loose lid should have been used as a secondary container, as opposed to plastic, which tends to become brittle and possibly break as it cools.
- A container with a lid that is designed to vent, rather than a screw cap, should have been used as a secondary vessel. It is possible that water vapor condensed around the edges of the screw cap, fusing the threads together, which made it difficult to open.

- Utilize insulated materials (such as styrofoam) with loose or vented lids when packing samples with dry ice.
- Do not force open containers that appear to be overpressurized.
- Wear proper protective equipment when working inside the laboratory or core facilities.

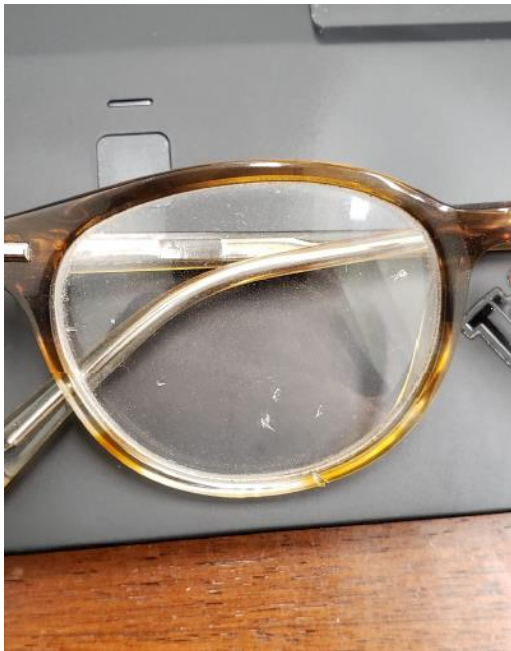
Photo 2 – Scratched Prescription Glasses

Researchers utilizing instrumentation in core facilities have been strongly advised to wear protective eyewear, even when not performing bench chemistry procedures.
