# Flooding Event and Improper Disposal of Glassware

## What Happened

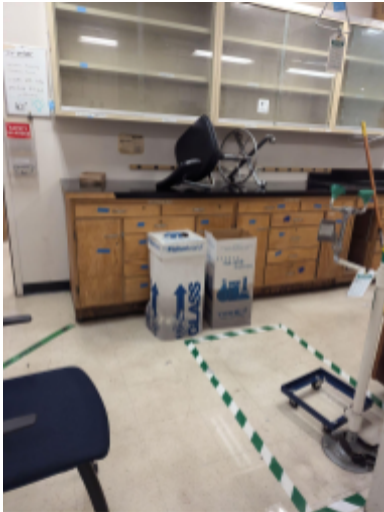
Soaked Cardboard  
Boxes

A serious concern emerged when floodwater seeped into cardboard boxes, used for clean glass disposal, that did not have plastic liners. Without this essential barrier, the integrity of the boxes were compromised, rendering them unsafe for handling and disposal.

As a result, safety responders had to take extra precautions to safely transfer the broken glass and sharps to new disposal bags using tongs. This was a very time-consuming and hazardous process that could have been avoided if the boxes were utilized as intended.

- The building was temporarily shut down for hazardous materials cleanup.
- Lab personnel reviewed proper waste management and disposal procedures.
- Polybag-lined glass disposal boxes to properly separate broken and contaminated glass were acquired by the lab.

- Always use a plastic liner for cardboard boxes that are used for glass disposal to provide an additional layer of protection against leaks, spills, and unexpected moisture exposure.
- Regularly inspect disposal bins for any signs of wear or weakness, especially in high-risk areas where environmental conditions could compromise their integrity (e.g., next to a sink)..
- Train lab personnel on proper waste disposal procedures to ensure everyone understands the importance of using liners and securely sealing waste containers.

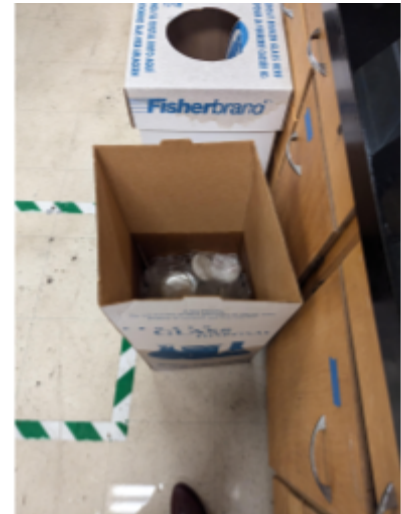
Top Down View of  
Water Damaged Box
